Manhole Inspection Summary

Manhole # S27E__011MH

Insp Date: **11/1/07 12:21 PM**

Location Address: **3112 VINE ST**

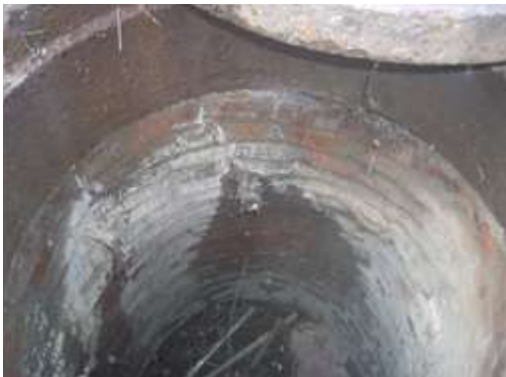
Defect 3

Infiltration: ☐ None ☐ Joint ☐ Cracks ☐ Mortar ☐ Roots ☒ **Wall**

INFILTRATION OF THE BARREL WALL

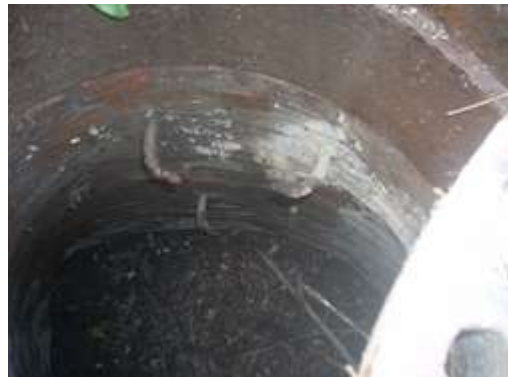
Defect 2

Infiltration: ☐ None ☒ **Joint** ☐ Cracks ☐ Mortar ☐ Roots ☐ Wall

Count: **0** Missing: **3** ☐ Corroded

MISSING STEPS WITH JOINT
INFILTRATION EVIDENCE

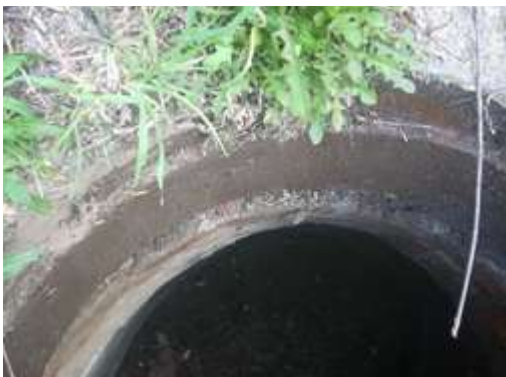
Defect 1

Offset: **0.5** (in.)

FRAME OFFSET

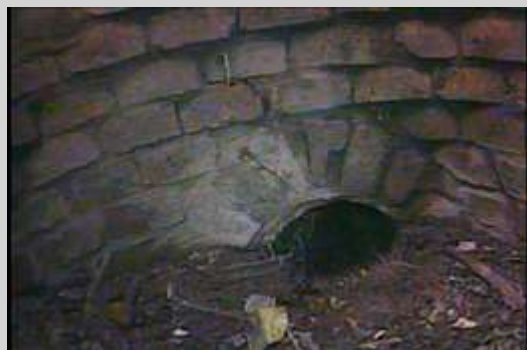
12 O'Clock Outflow

Deposits: ☐ None ☒ **Mud** ☐ Sludge ☐ Debris ☐ Grease

Silt Depth: **3** (in.) Deposits Extent: **Medium**
